**Table of Contents for 504 East 8<sup>th</sup> Street Tree Permit**  
**Heritage Tree Variance Package**

**ITEM FOR PLANNING COMMISSION AGENDA**

**ADDRESS**  
**OF PROPERTY:** 504 EAST 8<sup>TH</sup> STREET

**SUBJECT:** 504 East 8<sup>th</sup> Heritage Tree Ordinance Variance

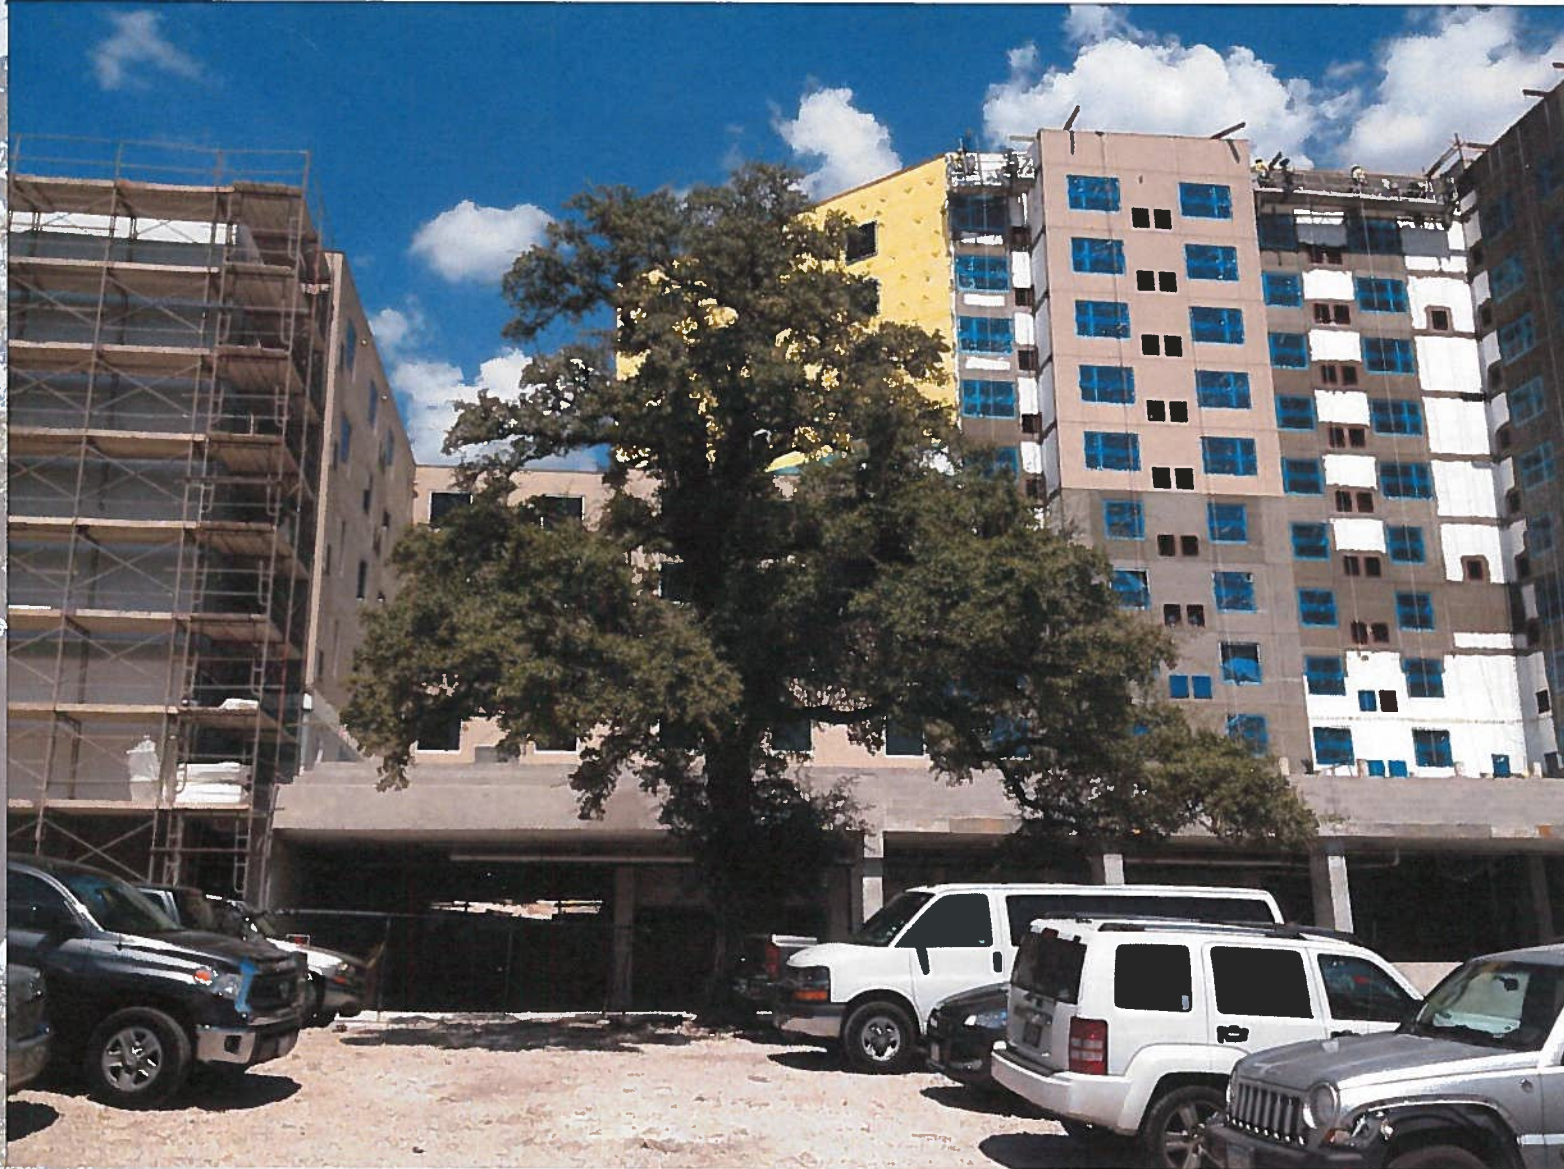
Exhibit 1

The canopy architecture displays minor asymmetry (Exhibit 1). Storm damage is evident in the canopy as the main leader has been damaged (Exhibit 2). Extensive epicormics growth is apparent (Exhibits 3 and 4). Epicormic growth is generally associated with the tree's response to stress likely related to the root system (see below).

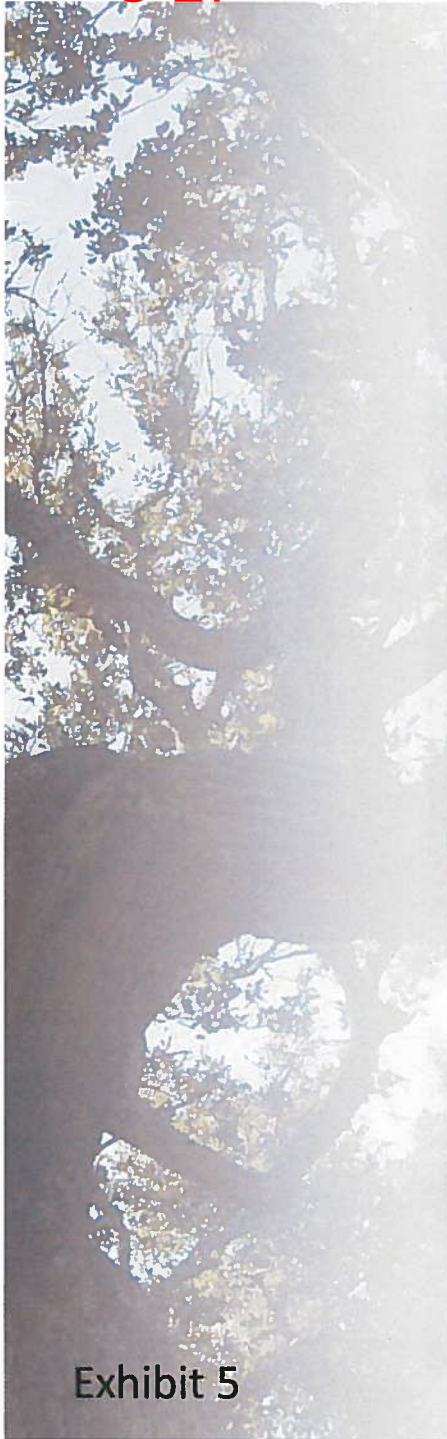
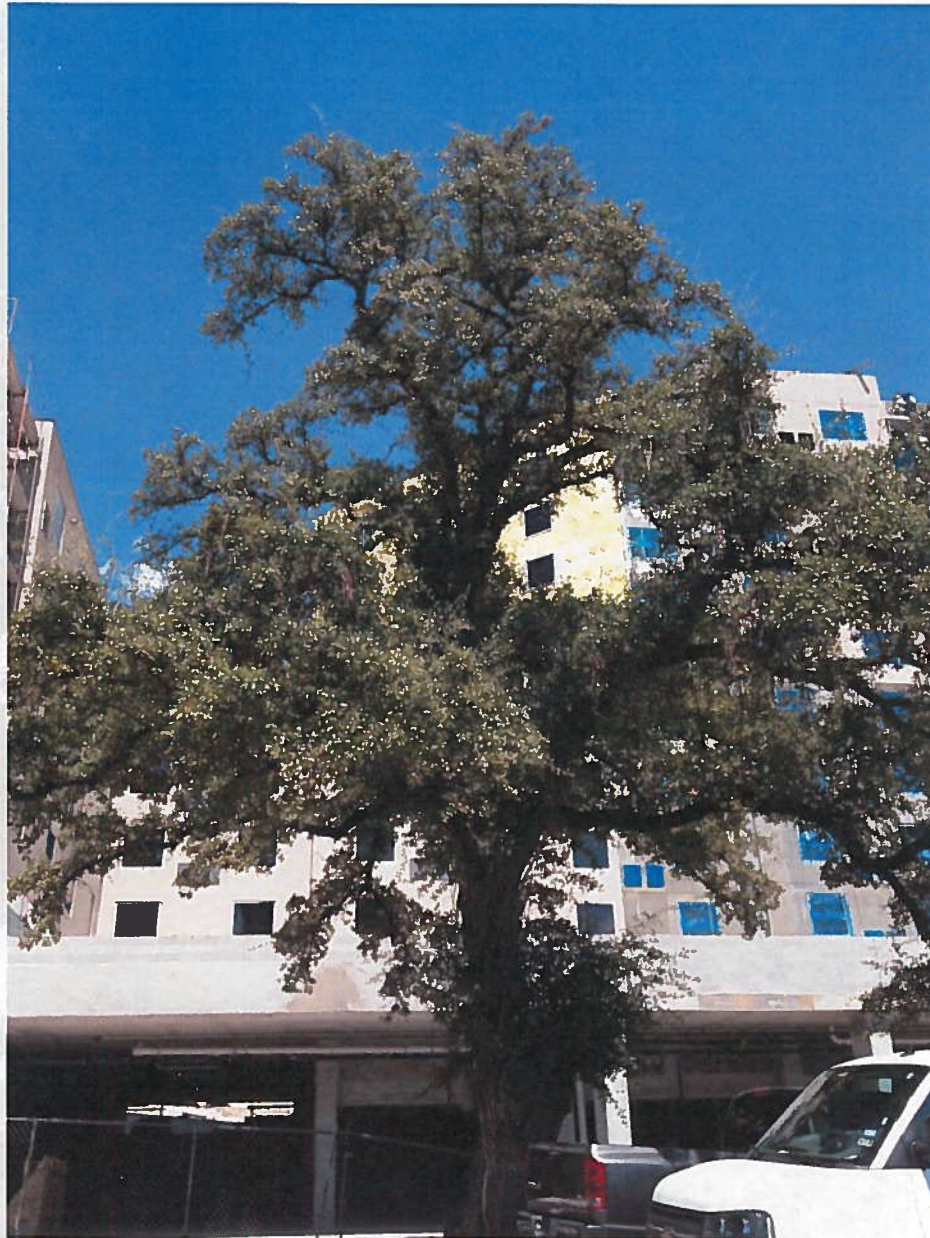
Exhibit 5

Storm damage is apparent in lower limbs (Exhibit 5). Otherwise, unremarkable.

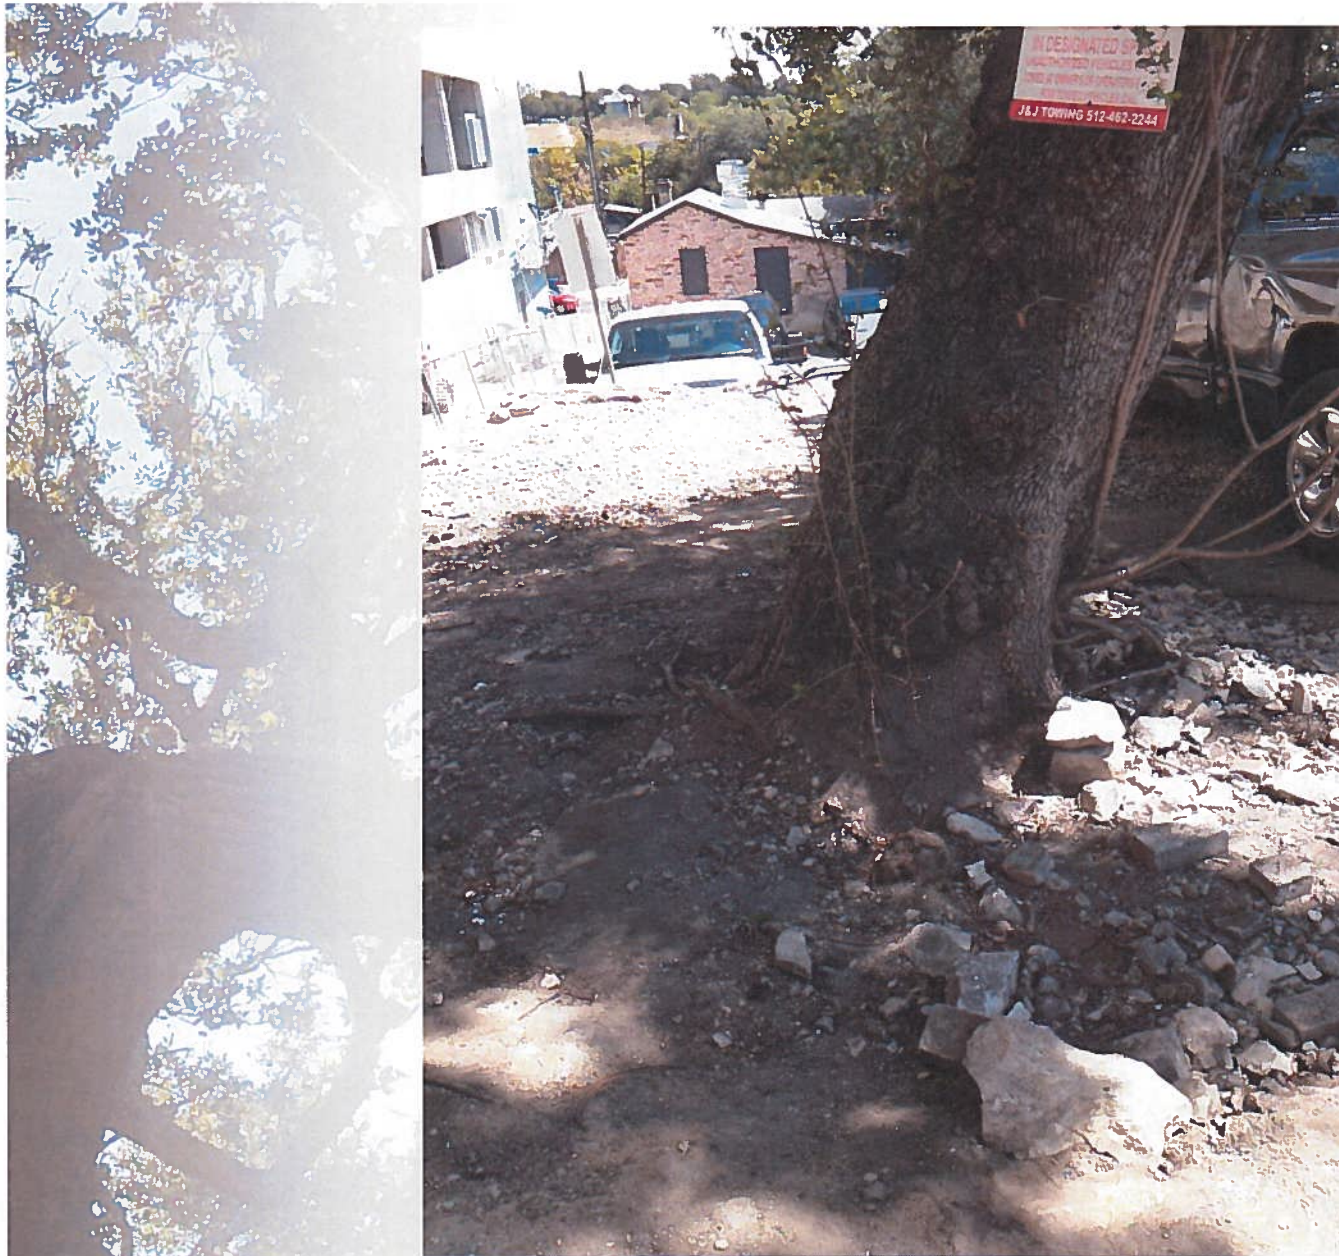
Exhibit 6

Root flare is buried under fill material (Exhibit 6). Critical root zone conditions are characterized by compacted parking areas (Exhibit 7) and cut on the northern half of the critical root zone (Exhibit 8). Girdling roots are present (Exhibit 9). Root decay is present. Extent of root decay is unknown but is a concern.

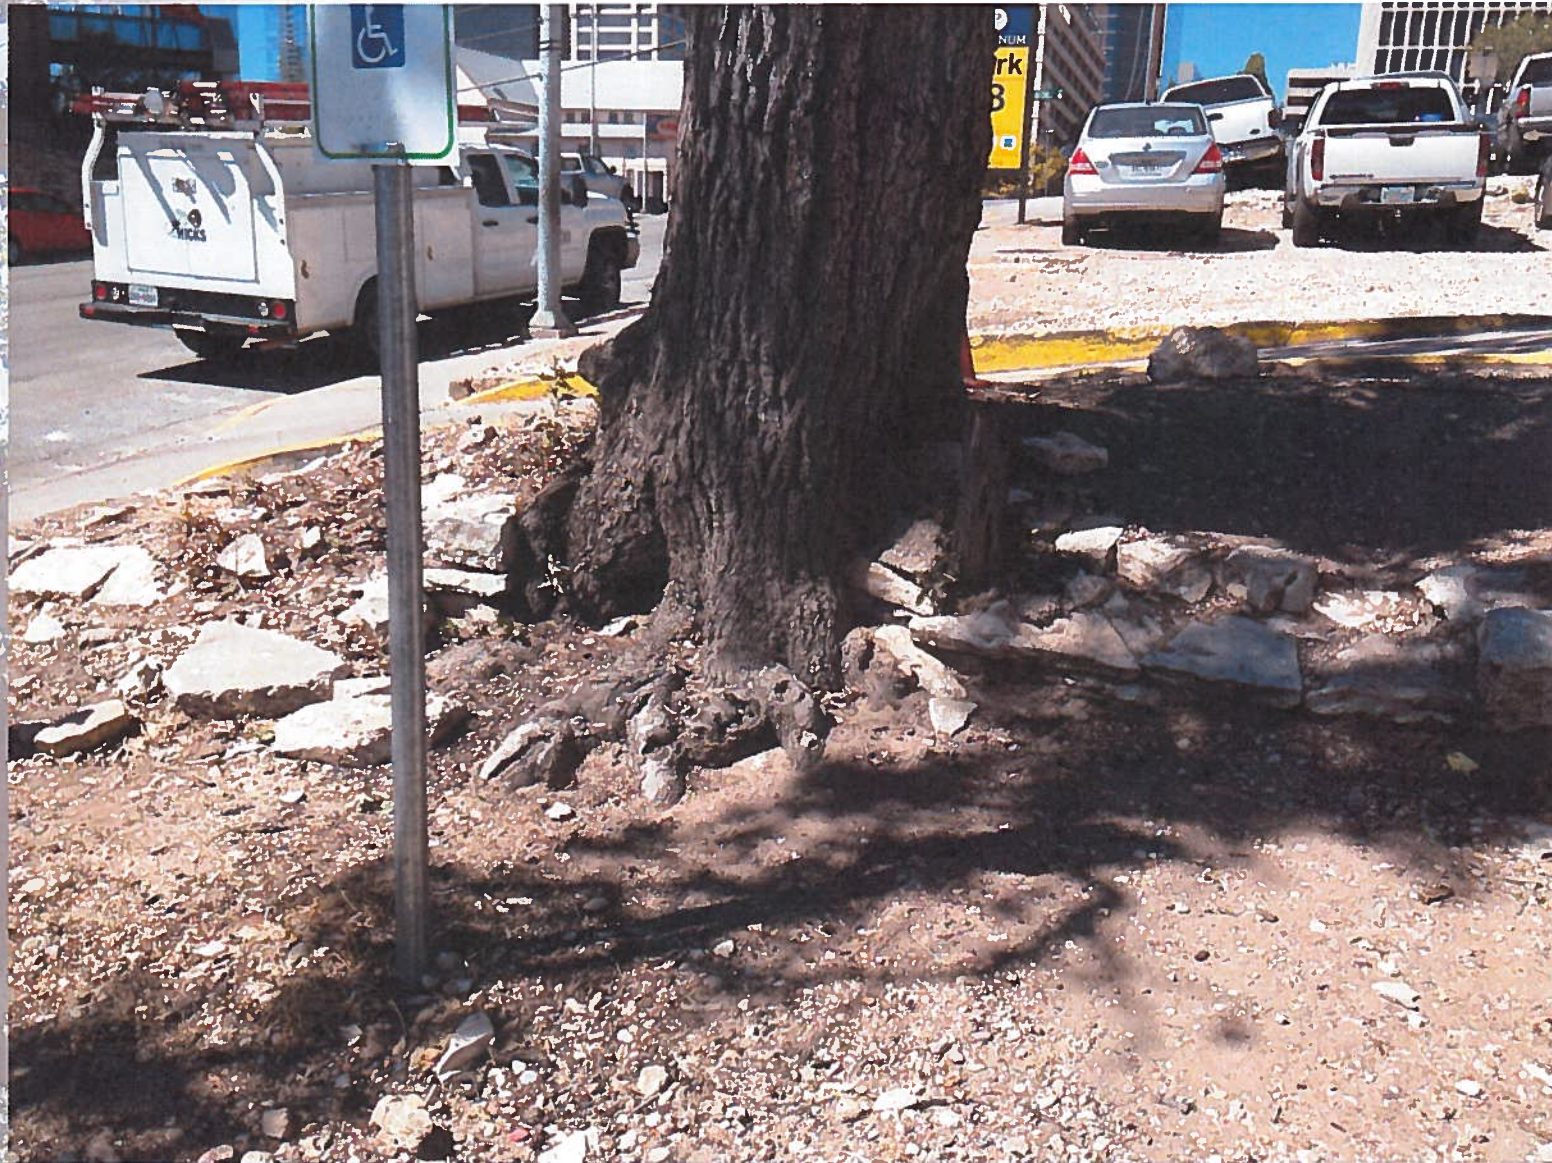
Exhibit 15

Root decay is apparent at the root flare of the subject tree (Exhibit 15). Fill material and grade cut impact the entire critical root zone (Exhibit 16). Soil heaving is apparent on the west side of the subject tree (Exhibit 17).

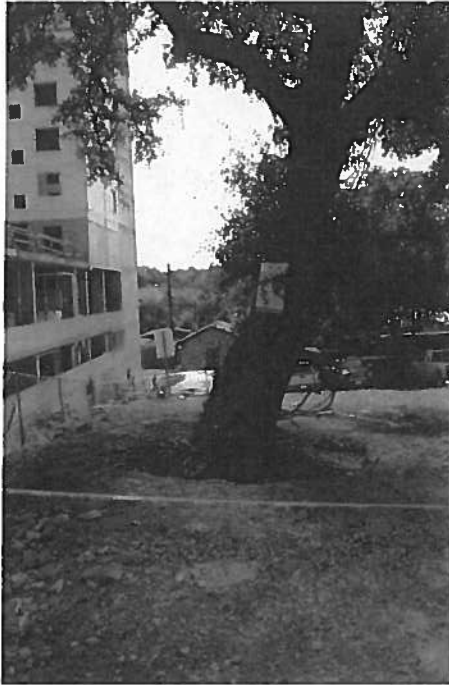
*The tree has a 25 to 30° lean out of plumb*

The most concerning situation perhaps is the lean of 25° to 30° to the south with the supporting roots on the north side of the tree severed and decaying. Mechanically out of balance, if left alone as a parking lot tree, this tree would eventually fail and would either cause property damage, personal injury, or both.

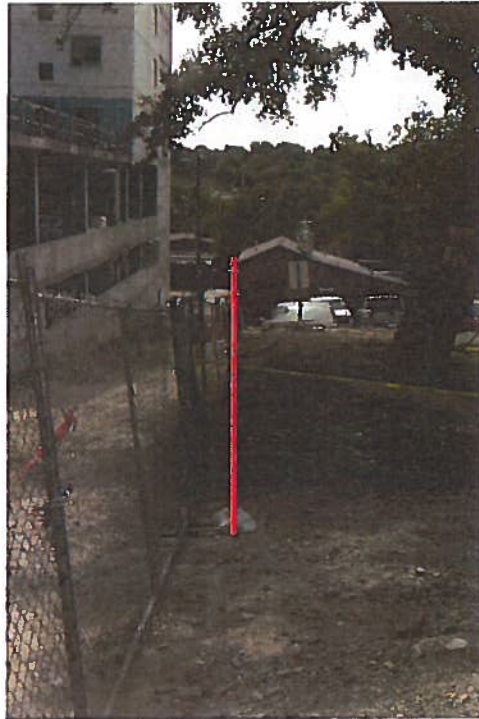
*All of the roots on the north side have been cut with several roots well in excess of 2-inches in diameter exposed on the north side of the tree showing signs of decay.  
View from west side.*

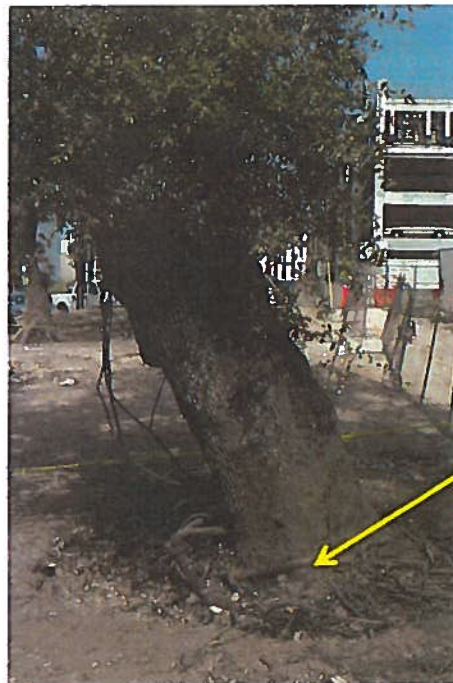
*View from east side – note excessive girdling roots.*

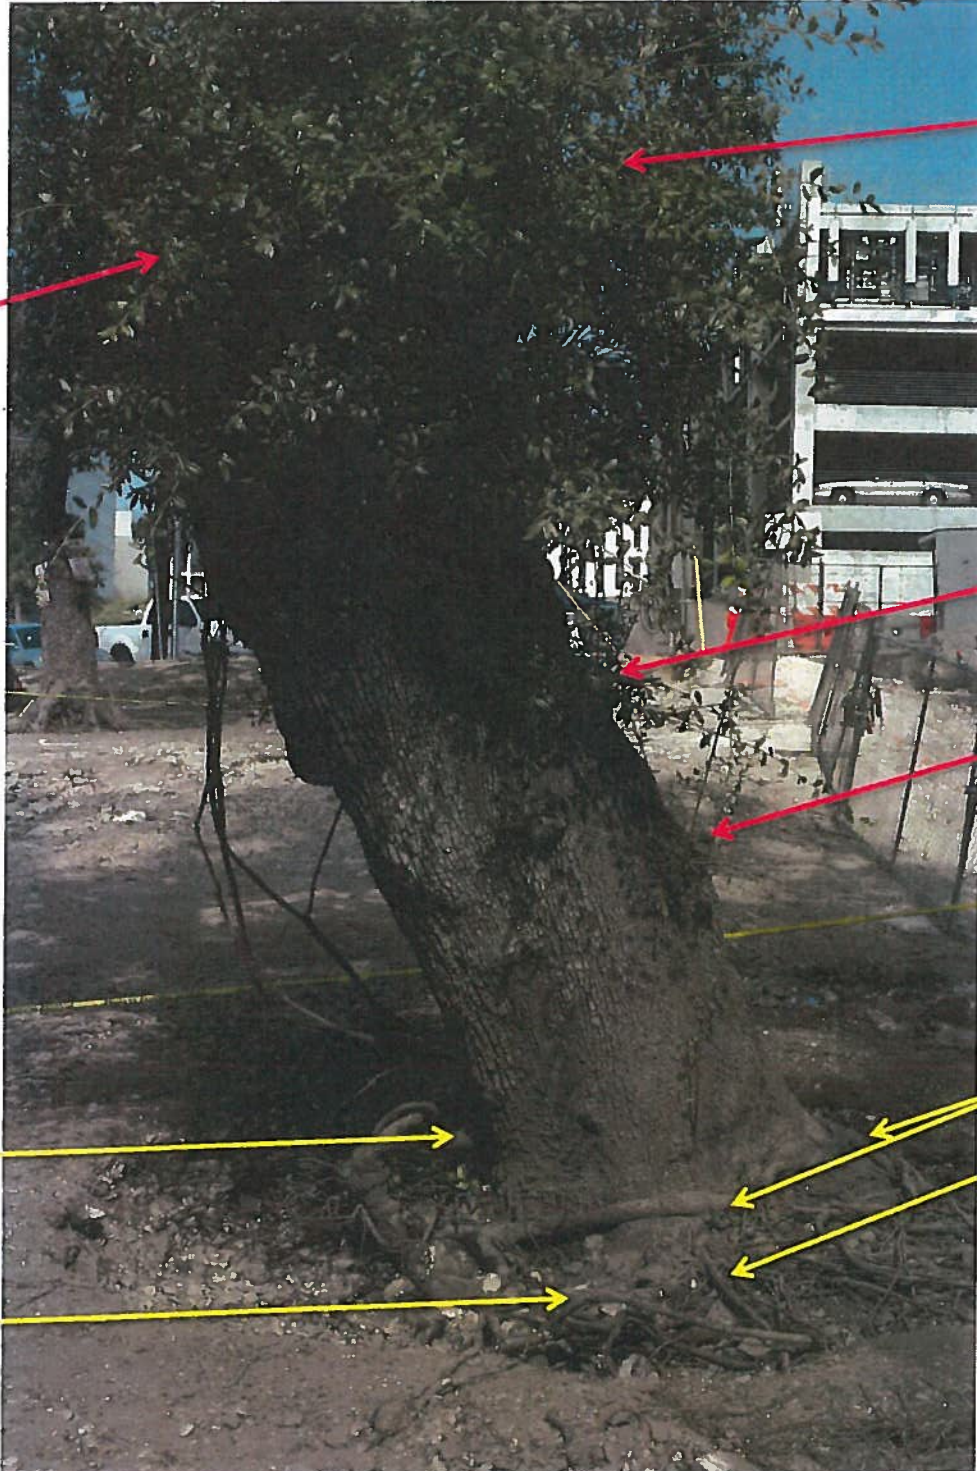
*Excessive girdling roots (yellow arrows) Root crown found to be buried 8 to 12-inches below grade with fill consisting of rubble, bricks, excessive soil and asphalt. Also note excessive epicormic sprouting on trunk (red arrows).*

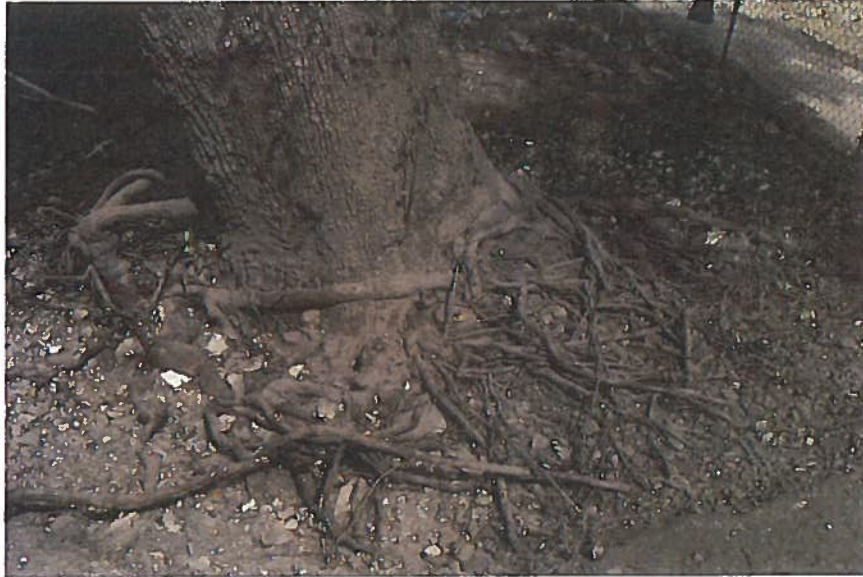
*Close up of girdling roots*

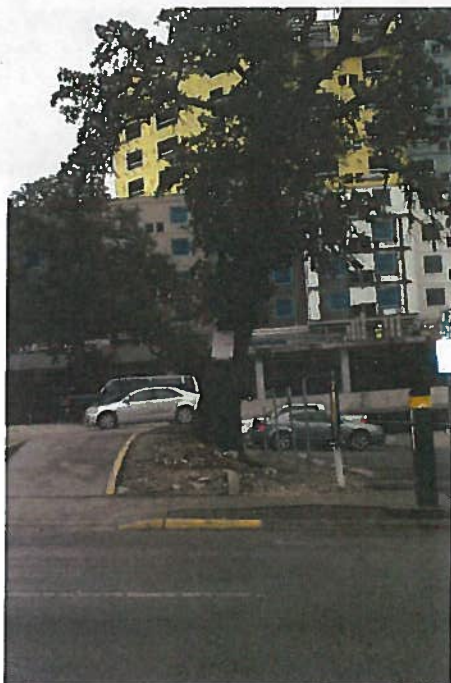
*30.5" Live oak with 20° lean to the east*

I have been following the decline of this tree for the last 5+ years. This year, for the first time, it is beginning to show the definitive signs of moving to the east. The lean has increased by 5 to 7 degrees. The curbing on the west side of the tree has lifted as has the paved driveway entrance indicating soil heaving. Branch tips dying in full sunlight indicate root damage.

After looking over the condition of the live oak at 504 East 8<sup>th</sup> Street (near the Eighth Street side) it is recommended that the tree be removed.

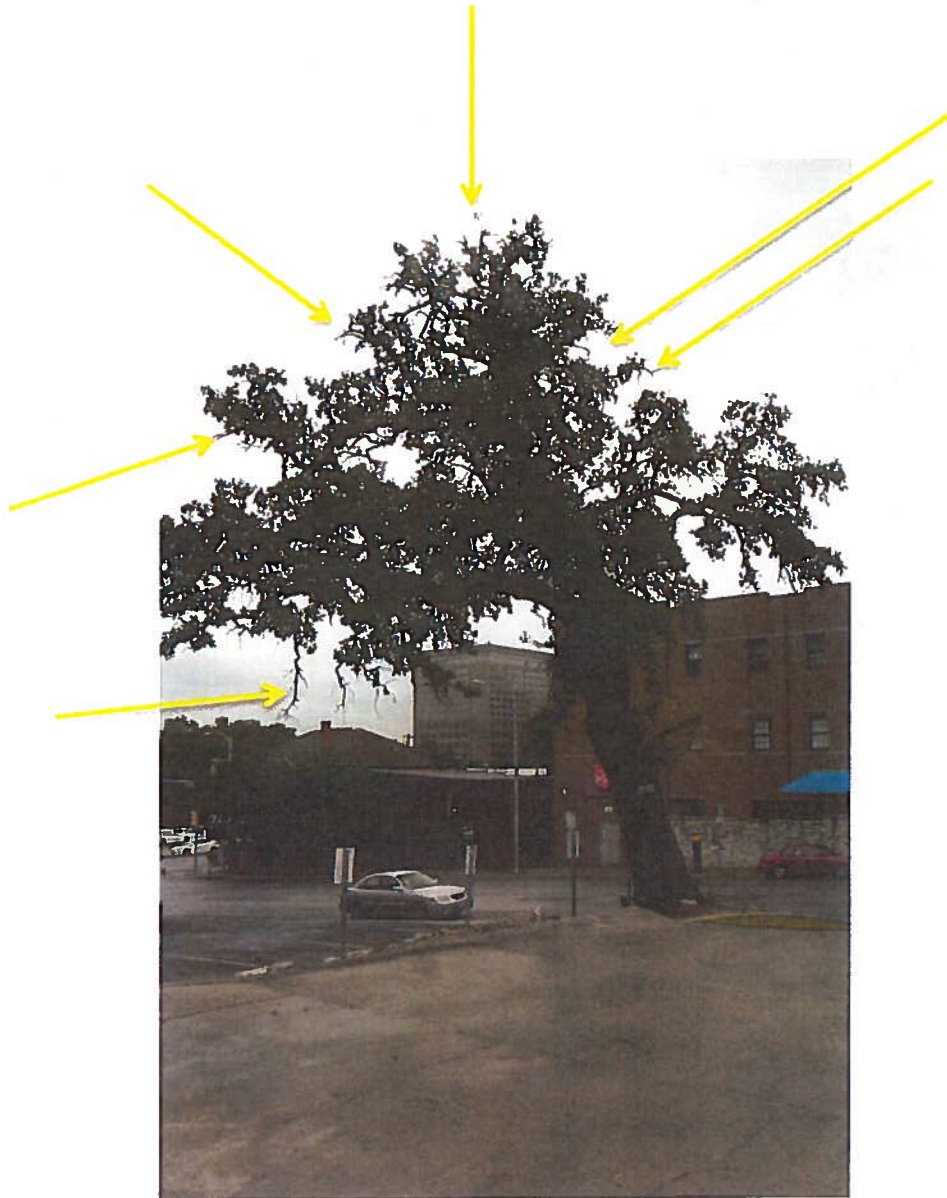
*Arrows indicate dead branches in full sunlight indicating root damage*

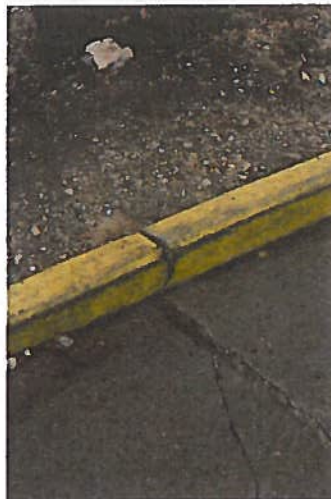
*Curbing cracked and lifted on the west side of tree opposite the lean*
